THE NOURISHMENT OF MOUNT LAVINIA BEACH

By Charitha Pattiaratchi¹, Nadiya Azmy² and Asha de Vos^{1, 2}

This paper relates to the recently concluded beach nourishment project undertaken at Mt. Lavinia beach in April 2020. Under the auspices of the Coast Conservation Department (CCD) of Sri Lanka, 150,000 m³ of sand extracted from two-six kilometers offshore from Ratmalana station was placed on a 500- meter length of Mt. Lavinia beach. The objective of the project has been defined as forming a 15-meter wide beach at Wellawatte through northward sand transport from Mount Lavinia (Daily Mirror, 2020).

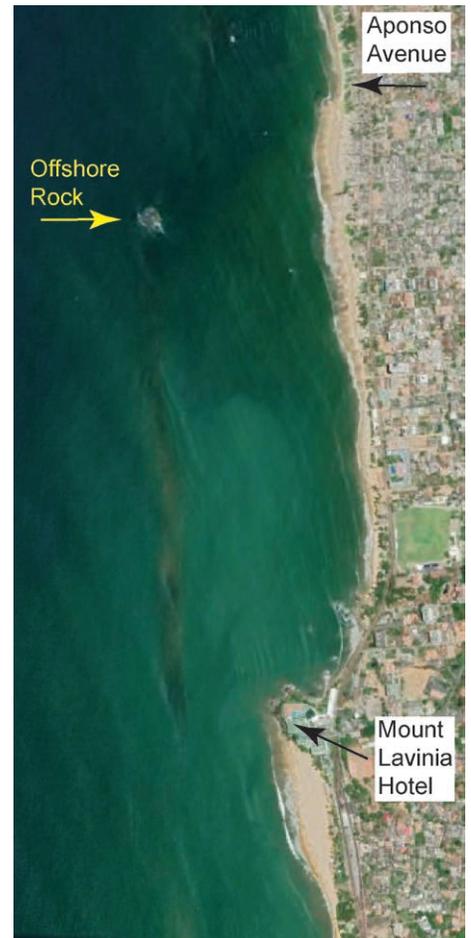
The stretch of beach between Mount Lavinia and Aponso Avenue is shown in Figure 2. The rock formation on the beach at the end of Aponso Avenue acts as a barrier to the northward sand transport. This results in a wider beach to the south for almost one kilometre. To the north of the rock at Aponso Avenue the shoreline indents but there is no erosion as evidenced by the presence of healthy vegetation (Figure 3).

Figure 2 : Mount Lavinia hotel to Aponso Avenue.

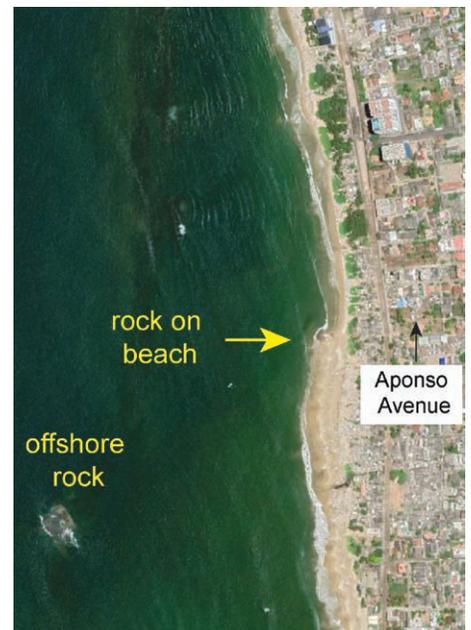
Figure 3 : Aponso Avenue to Station Road.

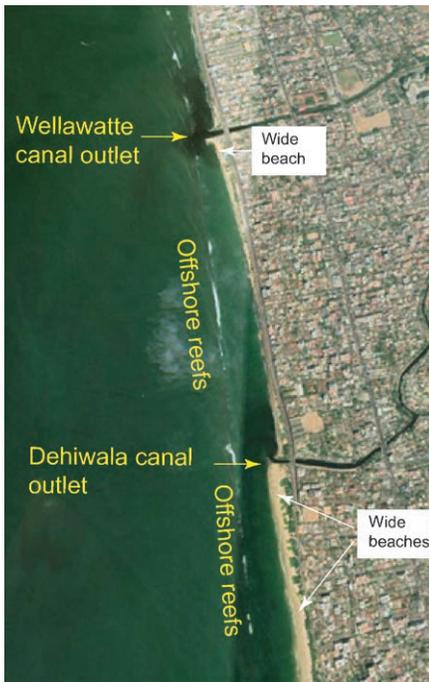
The 1.6 kilometre stretch of beach between the rock at Aponso Avenue and Dehiwala canal outlet is protected by a shallow reef parallel to the coast as evidenced by the breaking waves (Figure 4). The presence of the reef dissipates the wave energy and provides protection for the beach. Nevertheless, there is still sand transport with the training groynes at the canal entrance acting as a barrier for northward sand transport. There is accumulation of

sand to the south of the Dehiwala canal outlet (Figure 4). Again, there is no evidence of erosion along this stretch of the coastline. This is highlighted by examining the shoreline change maps created using the Sentinel satellite over the period of March 2016 to November 2019 (Figure 5). The seasonal changes as mentioned above are reflected in the maps but there is no systematic erosion.

Figure 4 : Dehiwela and Wellawatte canal outlets.

The pattern of sand accretion/deposition repeats at the canal outlets at Dehiwala and Wellawatte (Figure 4). Here, coastal structures have been built to prevent sand deposition at the outlet to keep it open. The accumulation of sand to the south of the outlets results in wider beaches while those to the north of these structures are narrow due to the trapping effect of the training groynes.
